# GILMORE LAKE, WASHBURN COUNTY

2024-2028 Aquatic Plant Management Plan  
WDNR WBIC: 2695800

Prepared by: Dave Blumer, Lake Educator  
December 2023

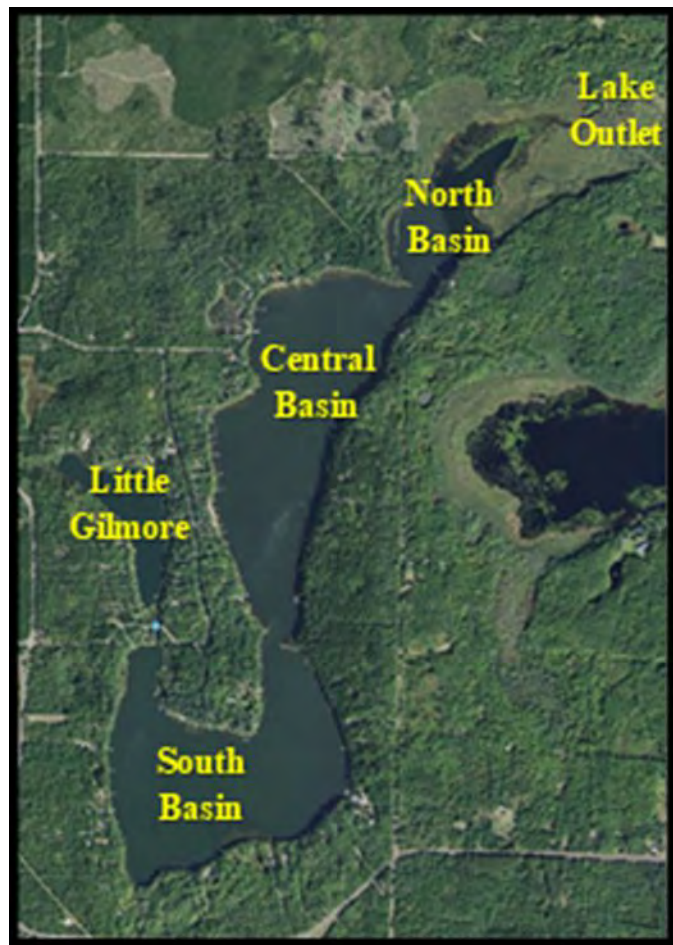
**Figure 4: Gilmore Lake aerial and identification of different basins (ERS, 2022)**

Gilmore Lake, including Little Gilmore Lake, is a 371 acre stratified drainage lake in north central Washburn County (Figure 4). According to the results of the 2022 whole-lake, point-intercept (PI) survey completed by Endangered Resource Services (ERS) the lake reaches 36.5 feet deep in the central basin and has a mean depth of 16.4 feet. There are no surface water tributaries to Gilmore Lake, and a single outlet at the northern end of the lake. The south basin of Gilmore Lake has the most varied underwater topography with two sunken islands and an expansive shallow flat on the south side of the lake (Figure 5). The deep central basin is characterized by sharp drop-offs; especially on the east side. The shallow north basin slopes gently towards the lake outlet moving from southwest to northeast. Little Gilmore forms a deep bowl with steep sides and a narrow littoral zone (Figure 5).

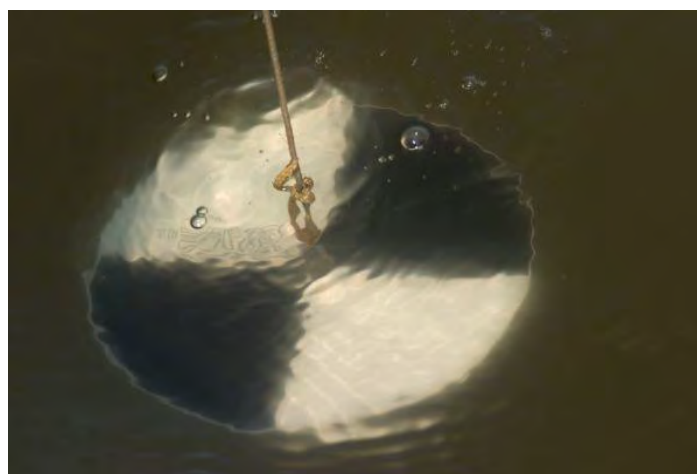
Water clarity is a measurement of how deep sunlight can penetrate the waters of a lake. It is most often measured using an 8" disk divided into four sections, two black and two white, lowered into the lake water from the surface by a rope marked in measurable increments (Figure 7). The water clarity reading is the point at which the Secchi disk when lowered into the water can no longer be seen from the surface of the lake. Water color (like dark water stained by tannins from nearby bogs and wetlands), particles suspended in the water column (like sediment or algae), and weather conditions (cloudy, windy, or sunlight) can impact how far a Secchi disk can be seen down in the water. Some lakes have Secchi disk readings of water clarity of just a few inches, while other lakes have conditions that allow the Secchi disk to be seen for dozens of feet before it disappears.

**Figure 7: Black and white Secchi disk**

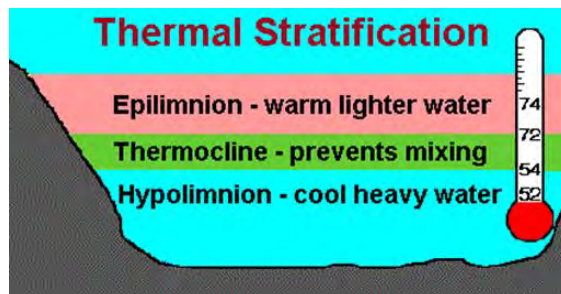
**Figure 13: Summer thermal stratification**

temperatures become colder and therefore denser causing that water to sink or fall through the water column. Below about 39°F, colder water becomes less dense and begins to rise through the water column. Water at the freezing point is the least dense which is why ice floats and warmer water is near the bottom (called inverse stratification) throughout the winter.

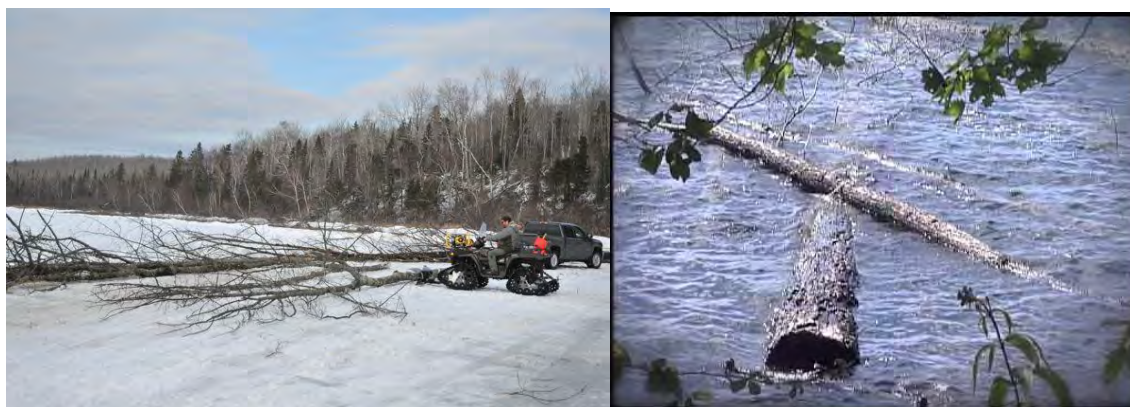
Small-scale CWH projects, more commonly referred to as “fishsticks,” can also be done by individual property owners, and are eligible for grant assistance through the WDNR Healthy Lakes program. This program is intended to help individual property owners make a positive impact on their lake’s ecosystem through small-scale projects such as fishsticks (Figure 19).

**Figure 19: Coarse woody habitat-Fishsticks projects**

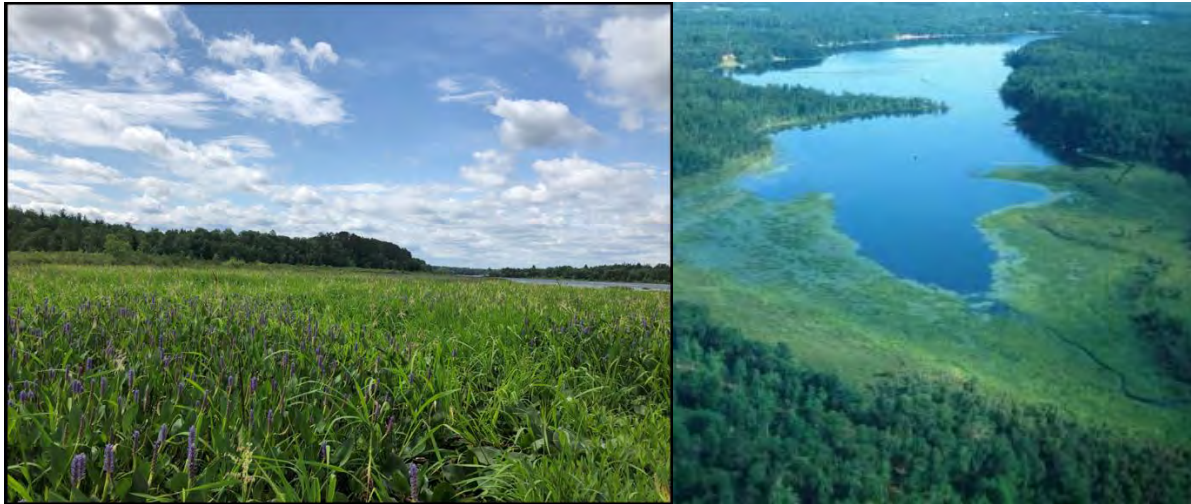
Gilmore Lake has long supported rice, but the bed is limited to the north end of the lake, near the outlet to the Totagatic River (Figure 35). Although this bed often appears to be harvestable, and harvest at the site is date-regulated, it rarely turns up in harvest surveys, perhaps because it is a long paddle from the public access to the rice bed. Interestingly, the outlet reportedly sometimes acts as an inlet; during flood conditions on the Totagatic River, flow has reportedly reversed, causing the level of Gilmore Lake to jump. This is probably detrimental to the rice beds when it occurs. Watch status is low due to site familiarity (David, 2010).

**Figure 35 – July 2022 wild rice at the outlet of Gilmore Lake looking toward the lake (left, ERS); Year 2000 aerial photo of wild rice at the Gilmore Lake outlet (David, 2010)**

In 2010, rice occurred at such a low density in the outlet bay that there were no true beds, and no attempt to delineate the total area with rice plants was made. The 2015 survey again found that very low-density rice was scattered among other emergents in the outlet bay. Again, a formal bed mapping survey was not completed, but the surveyor estimated that rice was present within an approximately eight-acre area. Despite this sizable coverage, the density was so low that there were no places that even approached having human harvest potential.

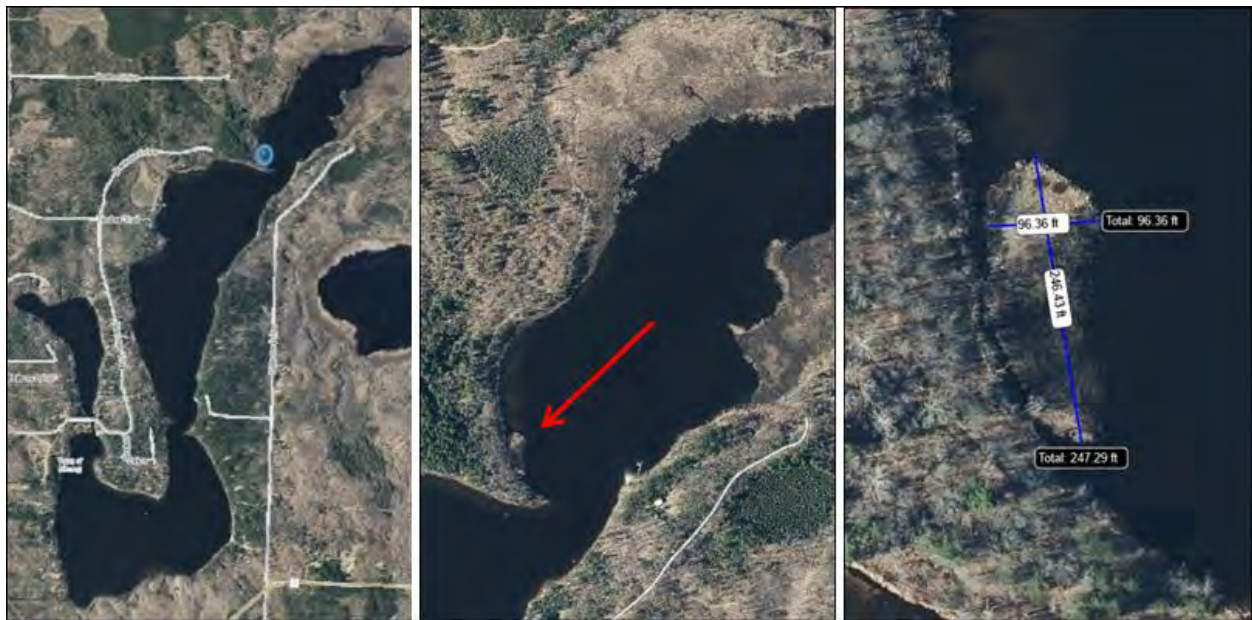
Concern has been expressed by members of the GLA related to a floating bog in the North Basin of the lake (Figure 38). The concern relates to how it moves around the North Basin when under high water conditions. The bog is currently blocking several privately owned lots and is directly in front of a newly constructed cabin. The bog moved across the lake from the Eastern shore to the Western shore in the flooding during 2018 (two floods with 5 & 7 feet over normal) and moved again in the spring flood of 2023 a few hundred yards to the north along the western shore.

Figure 38: Location of the floating bog in Gilmore Lake

The GLA board and the affected property owners would like to move the bog to undeveloped areas near the present location. GLA will explore removal options from the present location to a less intrusive area and will need assistance and advice from the WDNR and the lake consultant on appropriate management.

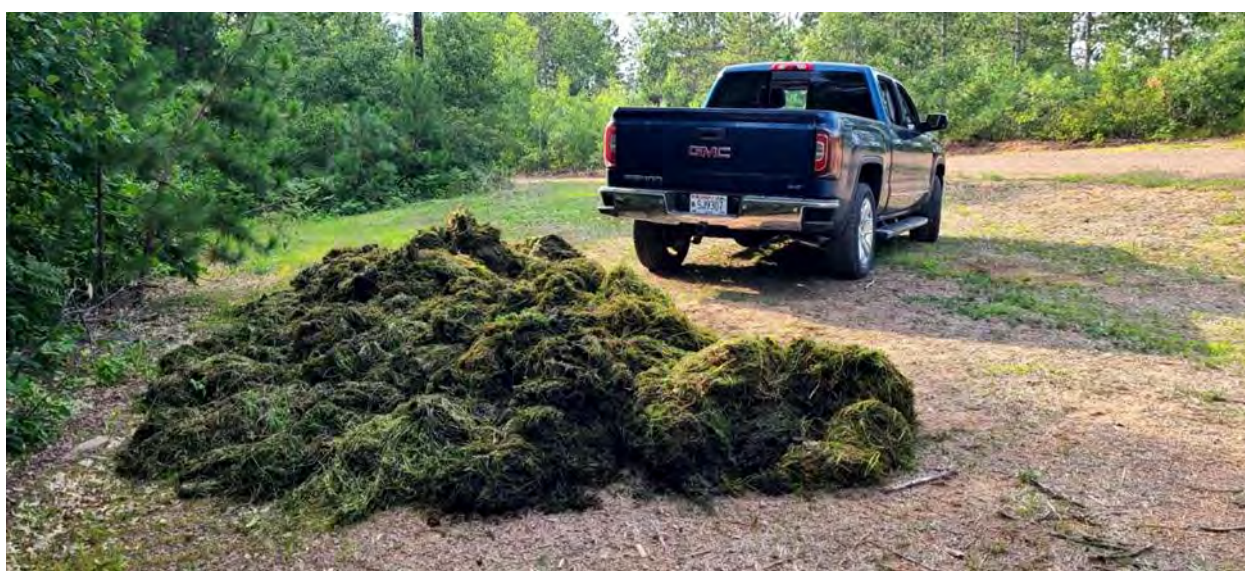
In early August 2023, the GLA contracted with a company that offers DASH removal of EWM. The company was brought in for three days of DASH removal focused primarily on the southeast shoreline of the North Basin across from the larger, 8-acre bed. During their time on the water, 132 onion bags of EWM were removed (Figure 41).

Figure 41: One day's DASH removal results (McCloskey, 2023)

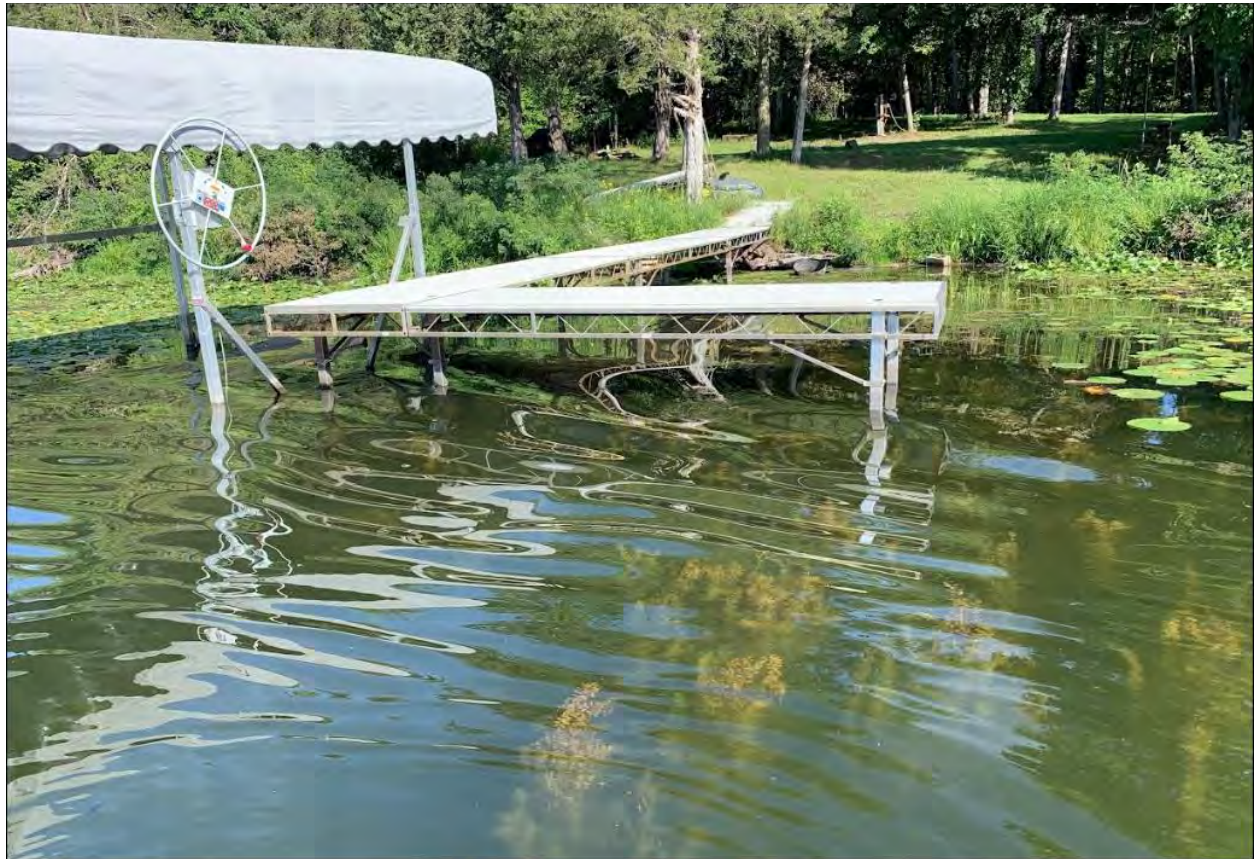
Although up to 30 feet of aquatic vegetation can be removed, removal should only be done to the extent necessary. Clearing large swaths of aquatic plants not only disrupts lake habits, it also creates open areas for non-native species to establish (Figure 45).

**Figure 45: “Cleared” shoreline and EWM on a local lake**

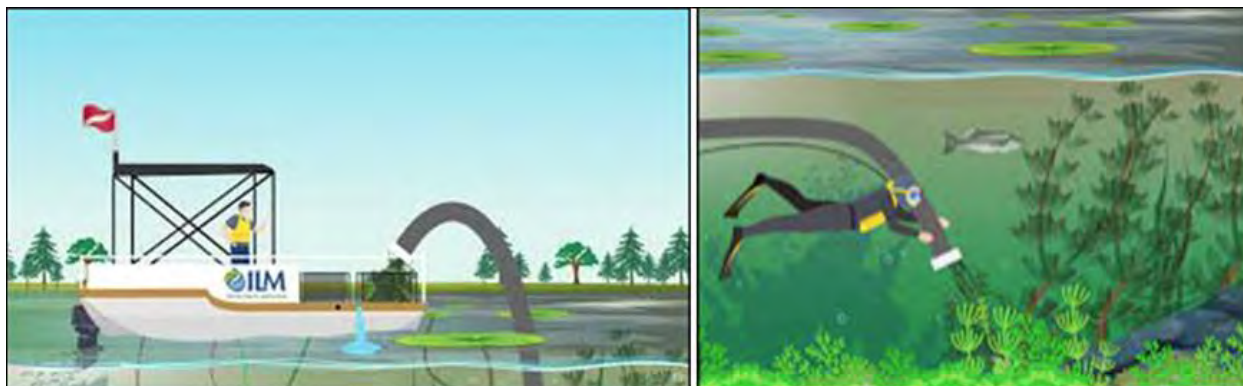
**Figure 46: DASH boat and underwater operation (ILM Environments)**

Diver assisted suction harvesting or DASH, as it is often called, is a recent aquatic plant removal technique. DASH involves scuba divers who swim along the bottom of the lake with a hydraulic suction tube and when a target plant is found, it is dislodged by the diver and fed into the suction tube. Hydraulic suction brings the removed plant to the surface of the lake and deposits into a bag or bin on the boat (Figures 46 and 47). It is called "harvesting" rather than "dredging" because, although a specialized small-scale dredge is used, bottom sediment is not removed from the system. DASH increases the ability of a diver to remove the offending vegetation from a larger area, faster, but also requires a Mechanical Harvesting permit from the WDNR. The cost to implement DASH is also more expensive than employing a diver alone. A DASH boat consists of a pontoon boat equipped with the necessary water pump, catch basin, suction hose, and other apparatus (Figure 47).

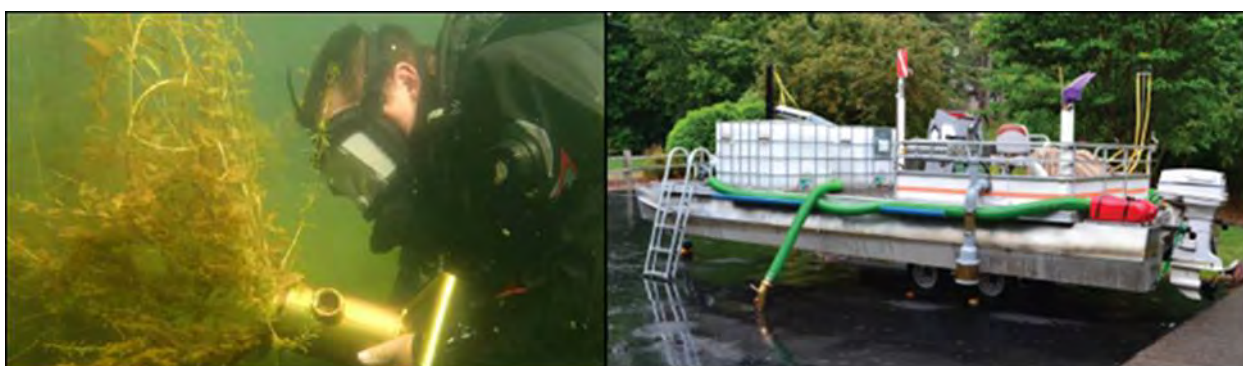
**Figure 47: DASH – Feeding EWM into the underwater Suction Hose (Marinette Co.); and a sample DASH Pontoon Boat (Beaver Dam Lake Management District)**

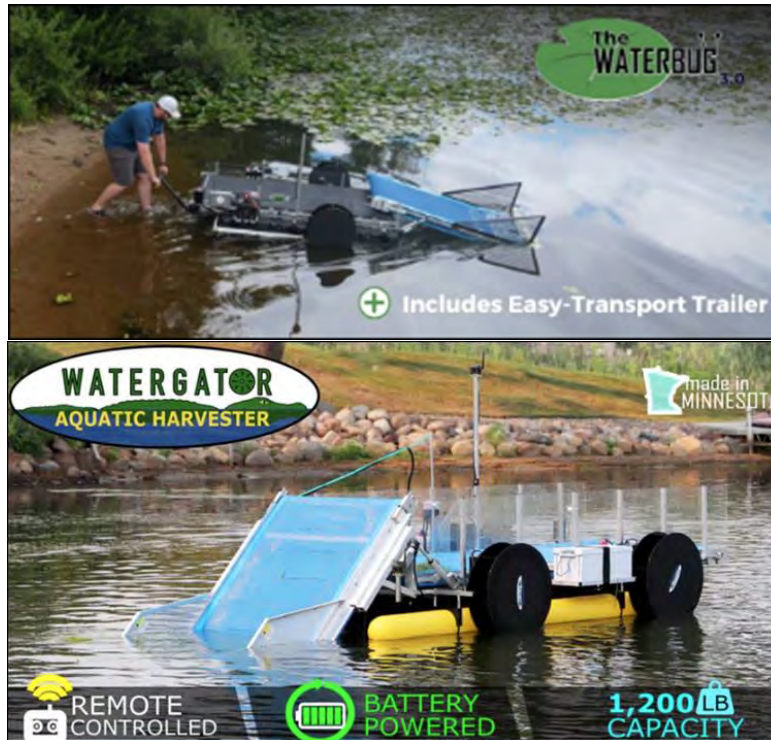
A more recent option for small-scale mechanical harvesting of aquatic plants is using a “mini” harvester that is remote-controlled. Weeders Digest currently offers two versions of a remote controlled mini mechanical harvester, the WaterBug and the WaterGator (Figure 49).

Figure 49: Waterbug and Watergator remote controlled mini aquatic plant harvesters  
<https://lakeweederharvester.com/waterbug/>

The cost of a WaterBug is estimated at around \$17,000.00. The cost of a WaterGator is about double that at \$35,000.00.

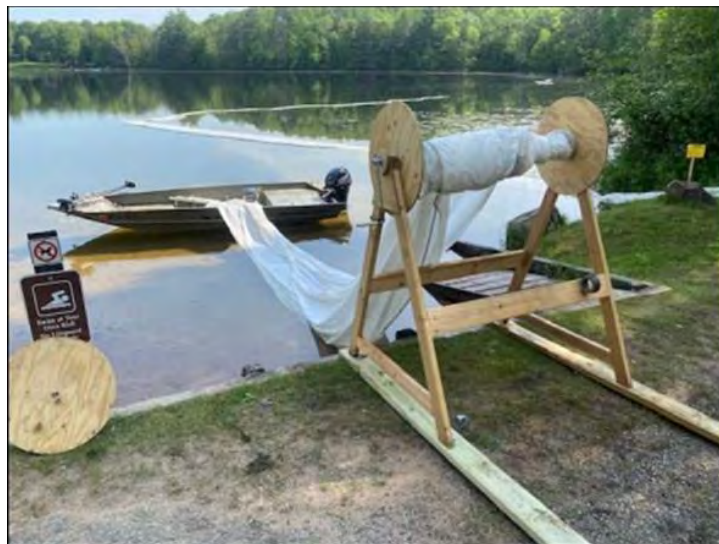
Small-scale herbicide applications can be made more effective by installing a limno-barrier or curtain around a treatment area to help hold the applied herbicide in place, longer. By doing so, the herbicide/target species contact time is increased. The curtain is generally a continuous sheet of plastic that extends from the surface to the bottom of the lake (Figure 52). The surface edge of the curtain is generally supported by floatation devices. The bottom of the curtain is held in place by some form of weighting. The curtain or barrier, sometimes thousands of feet of it, is installed around the proposed treatment area with the purpose of holding the herbicide in place longer by preventing dilution and drifting away from the treated area (Figure 53).

**Figure 52: Limno-curtain material on a roll before installation (photo from Marinette Co. LWCD)**

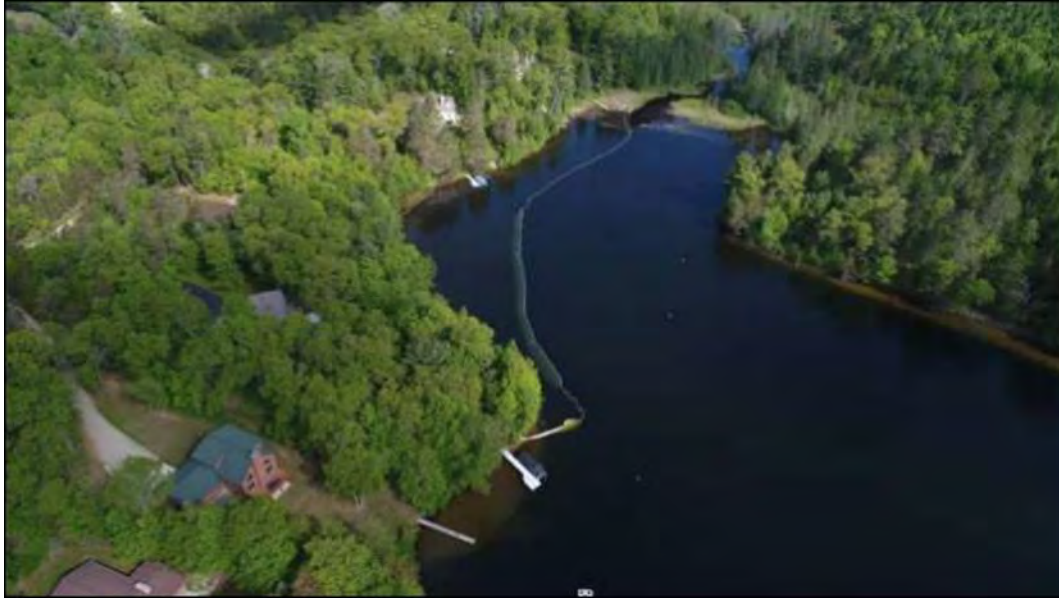
**Figure 53: Limno-curtain installed on Thunder Lake (photo from Marinette Co. LWCD)**

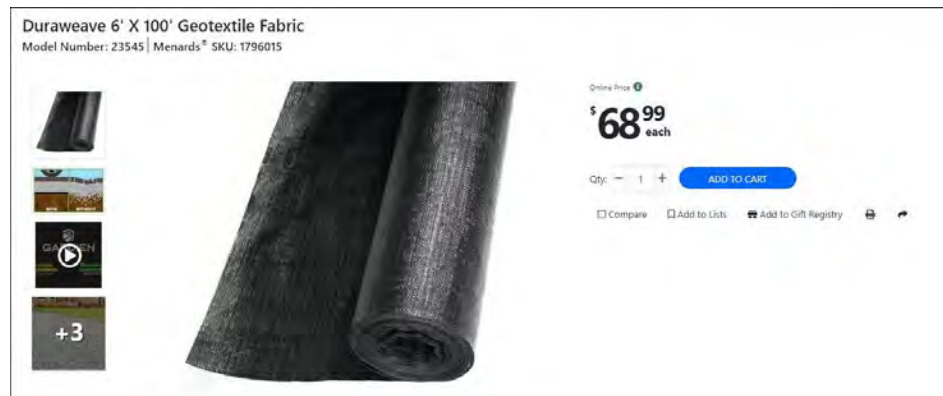
The installation of a limno-curtain would likely improve the results of small-scale EWM management (<3 to 5 acres), particularly when using liquid 2,4D products. The curtain should be installed all the way around any treatment area, be constructed in such a way that there are few gaps between multiple sections of curtain (if needed), anchored on the bottom-edge of the curtain, and floats installed on the top-edge of the curtain. If posts are driven into the bottom of the lake in shallow water to support the curtain, gaps between the posts and the curtain should be minimized to the extent possible. An example of material that could be used is shown in Figure 55.

Figure 55: Limno-curtain material

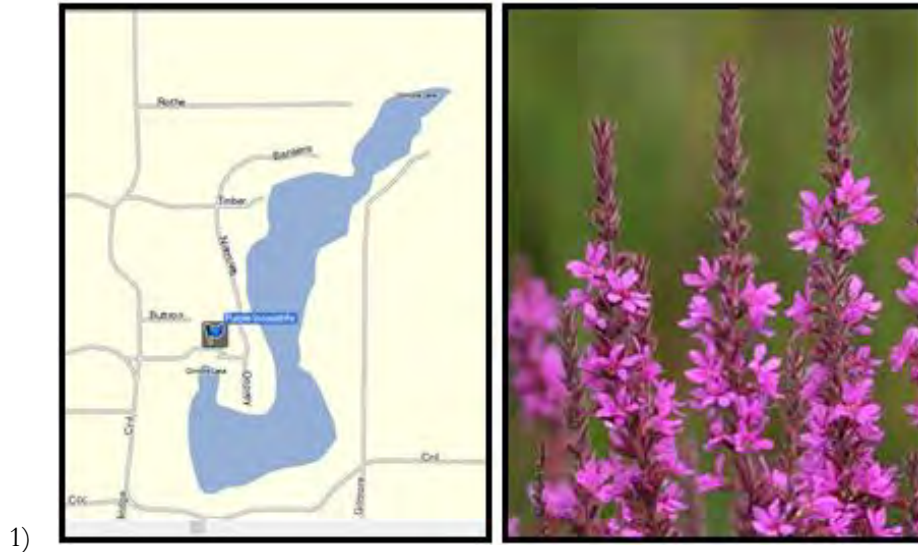
Purple loosestrife was found growing in the yards of private residences just beyond the lakeshore in Little Gilmore Lake (Figure 3). It can also be found in several wetland areas nearby including several places along the Minong Flowage, Gordon-St. Croix Flowage, and Upper Saint Croix Lake, and in the Hwy 53 median.

**Figure 3: 2015 Purple loosestrife distribution in Gilmore Lake**

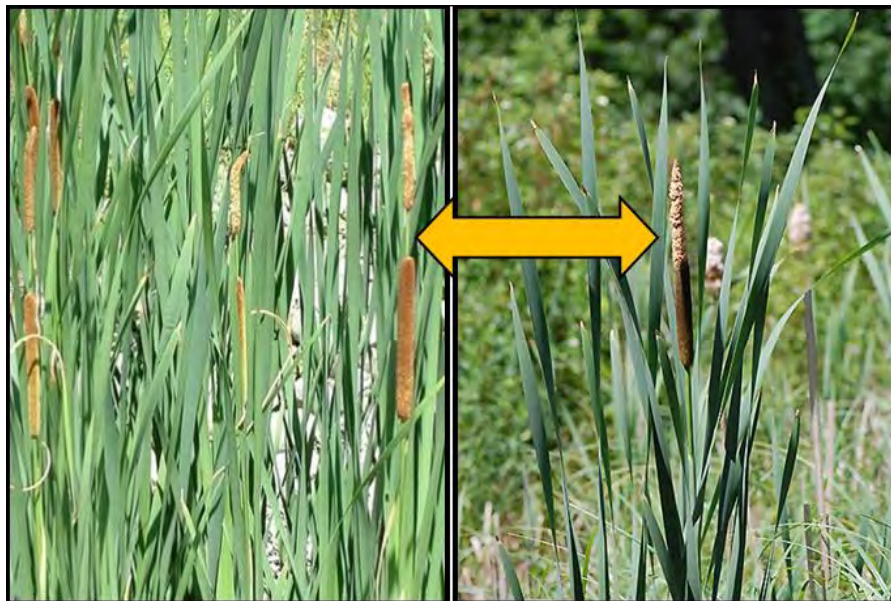
Figure 5: Hybrid cattail

Hybrid cattail (Figure 5) is native to southern but not northern Wisconsin, Narrow-leaved cattail (*Typha angustifolia*) and its hybrids with Broad-leaved cattail are becoming increasingly common in northern Wisconsin where they also tend to be invasive. Besides having narrower leaves, the exotics can be told from native cattails by having a relatively narrower and longer “hotdog-shaped” tan female cattail flower whereas the native species tends to produce a fatter and shorter “bratwurst-shaped” dark chocolate colored female flower. Narrow-leaved cattail and its hybrids also have a male flower that is separated from the female flower by a thin green stem while the native Broad-leaved cattail has its male and female flowers connected (Figure 49).

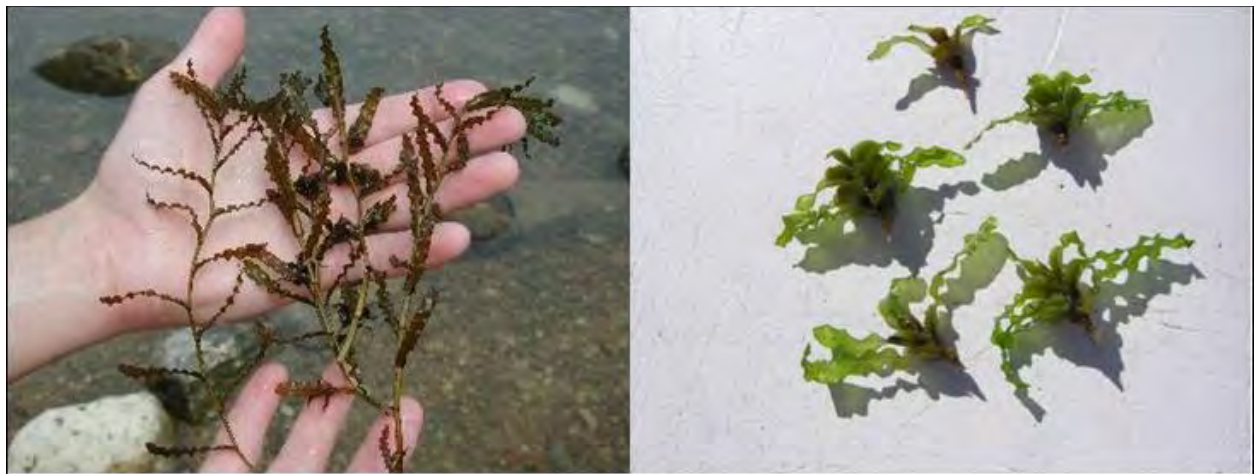
**Figure 6: Curly-leaf pondweed and its turions**

CLP is an invasive aquatic perennial that is native to Eurasia, Africa, and Australia (Figure 6). It was accidentally introduced to United States waters in the mid-1880s by hobbyists who used it as an aquarium plant. The leaves are reddish-green, oblong, and about 3 inches long, with distinct wavy edges that are finely toothed. The stem of the plant is flat, reddish-brown and grows from 1 to 3 feet long. CLP is commonly found in alkaline and high nutrient waters, preferring soft substrate and shallow water depths. It tolerates low light and low water temperatures. It has been reported in all of the lower 48 states.

CLP spreads through burr-like winter buds (turions) (Figure 6), which are moved among waterways. These plants can also reproduce by seed, but this plays a relatively small role compared to the vegetative reproduction through turions. New plants form under the ice in winter, making curly-leaf pondweed one of the first nuisance aquatic plants to emerge in the spring. It becomes invasive in some areas because of its tolerance for low light and low water temperatures. These tolerances allow it to get a head start on and out-compete native plants in the spring. In mid-summer, when most aquatic plants are growing, CLP plants are dying off. Plant die-offs may result in a critical loss of dissolved oxygen. Furthermore, the decaying plants can increase nutrients which contribute to algal blooms, as well as create unpleasant stinking messes on beaches. CLP forms surface mats that interfere with aquatic recreation.

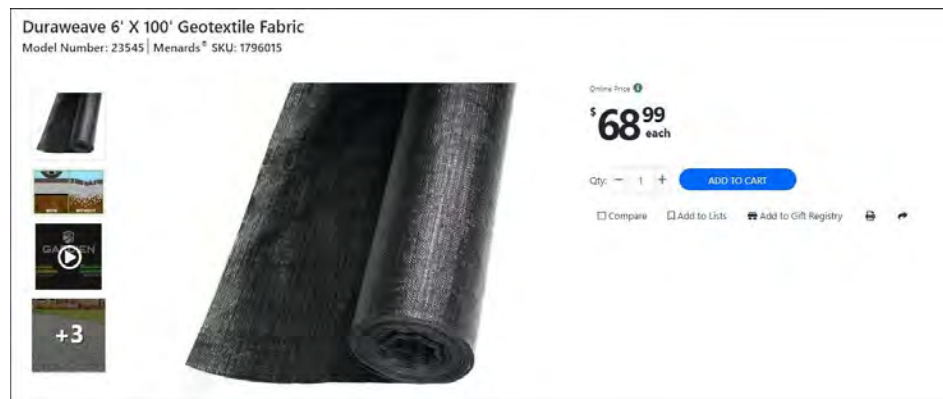
Figure 1: Limno-curtain material

The installation of a limno-curtain would likely improve the results of small-scale EWM management (<3 to 5 acres), particularly when using liquid 2,4D products. The curtain should be installed all the way around any treatment area, be constructed in such a way that there are few gaps between multiple sections of curtain (if needed), anchored on the bottom-edge of the curtain, and floats installed on the top-edge of the curtain. If posts are driven into the bottom of the lake in shallow water to support the curtain, gaps between the posts and the curtain should be minimized to the extent possible. An example of material that could be used is shown in Figure 1.
